MONUMENT RECORD
State of Indiana - County of Monroe

Corner ID: Wash W-15

RECOVERY TIE DRAWING

Section Twenty-four(24), Township 10 North, Range 1 West

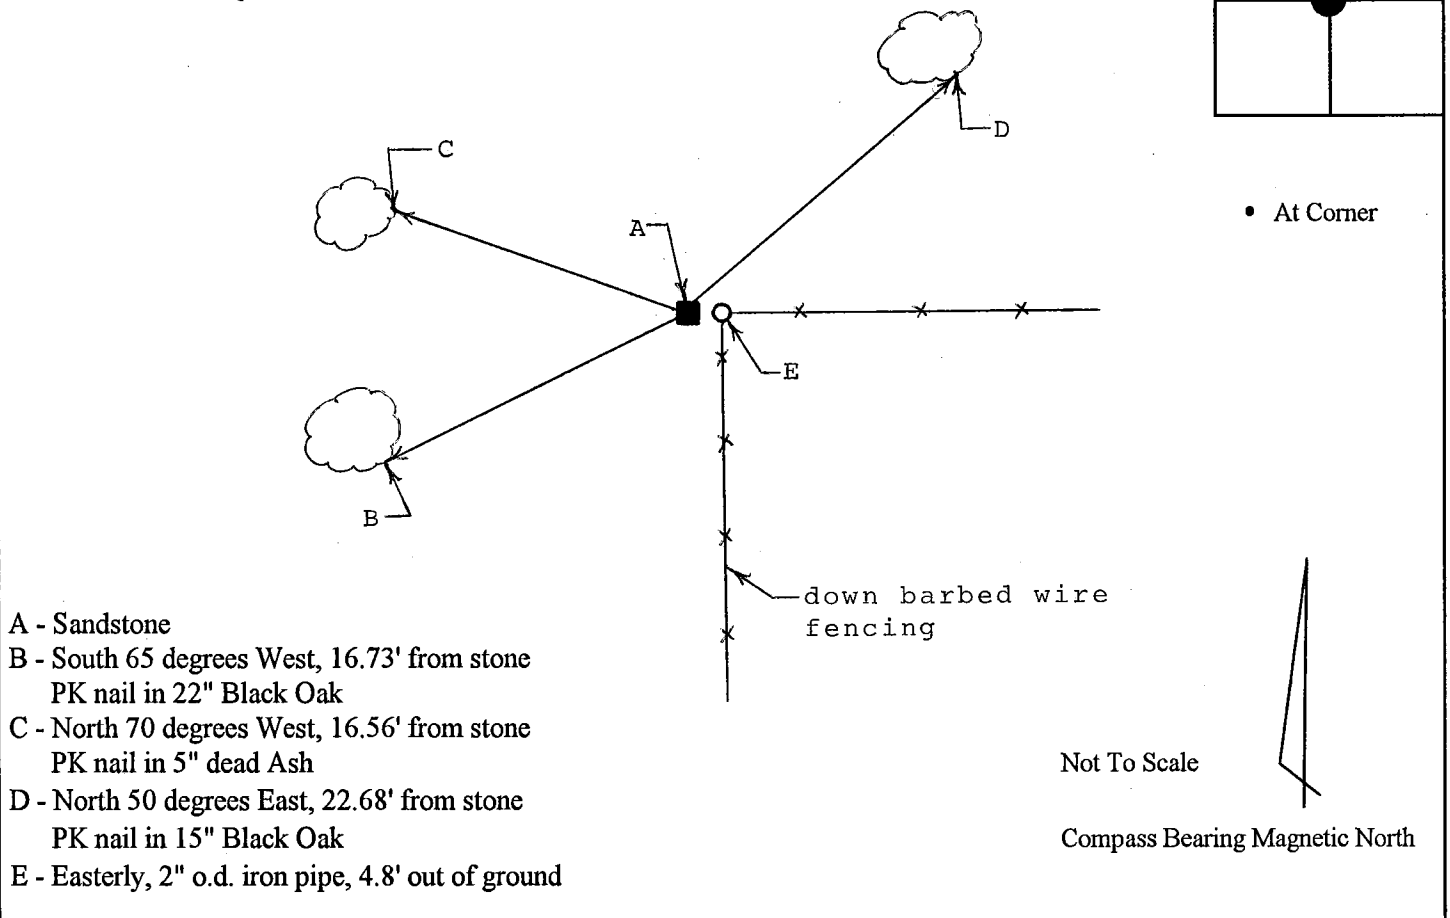
Monument Description & Remarks: Found Sandstone marked with new and old pink flagging at Center 1/4 of section. Sandstone measured 0.2' x 0.6' x 0.3' out of ground; SW 1/4 of stone broken off yet still intact with supporting rebar.

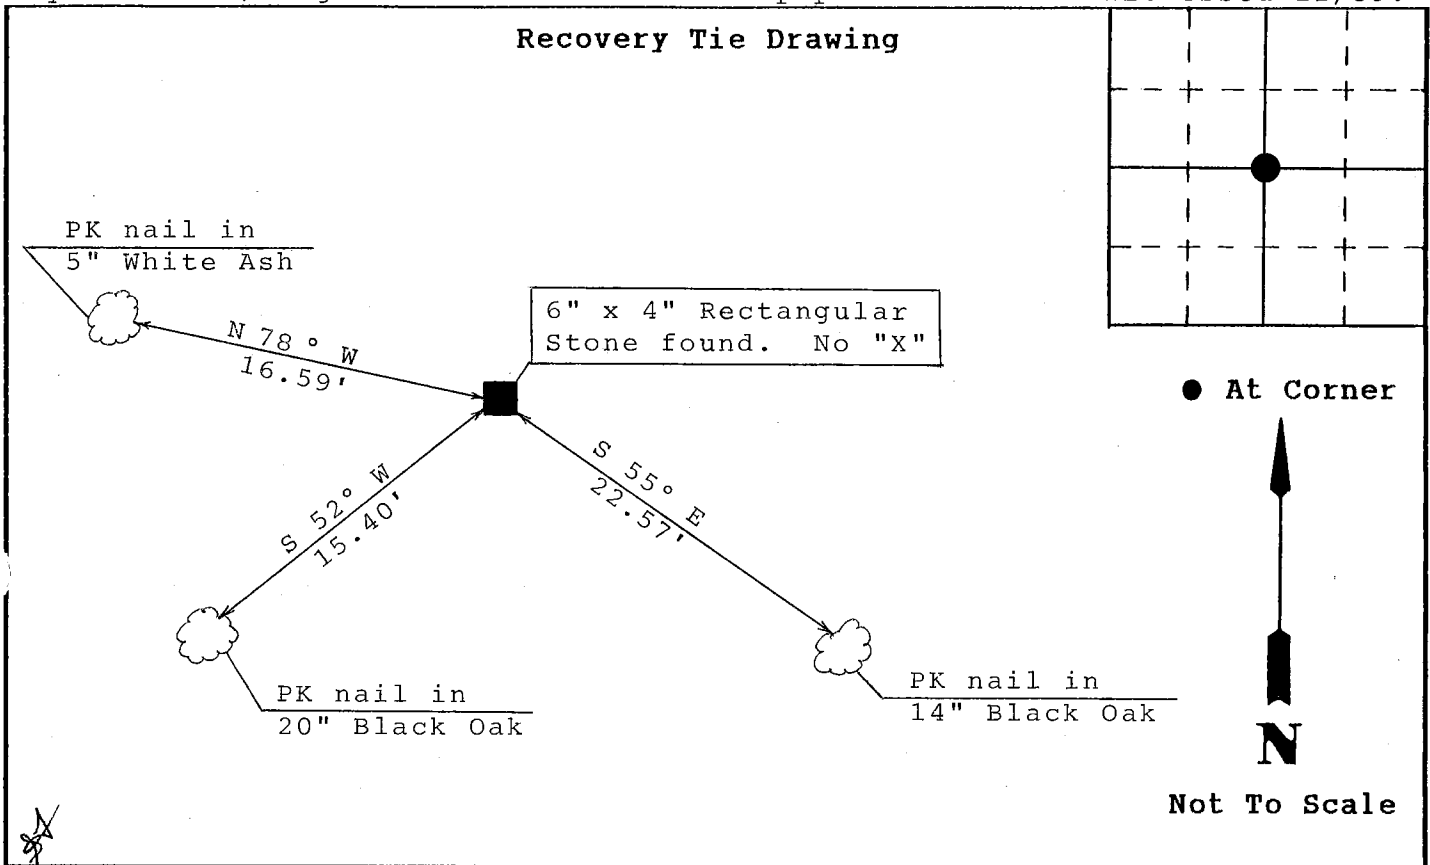
Recovery Tie Drawing

Monument Description & Remarks: Rectangular Stone, 6" x 4", found at center of section. Stone was exposed 1.5" and split along one side and reinforced by 2 rebars; adjacent to a 1.5" hollow pipe 4.5' tall. Witnessed 12/89.
